SERVICE BULLETINS

Model Code	Side Label	Part No.				
		Panel Module	Inverter	T-Con	Main B'd	Power
LN40D630M3FXZA	SQ01	BN07-01032A	BN81-06514A	BN81-06512A	BN96-19438A	BN44-00464A
	SN02	BN07-01037A	BN81-06720A	BN81-06719A	BN96-19774A	BN44-00464A

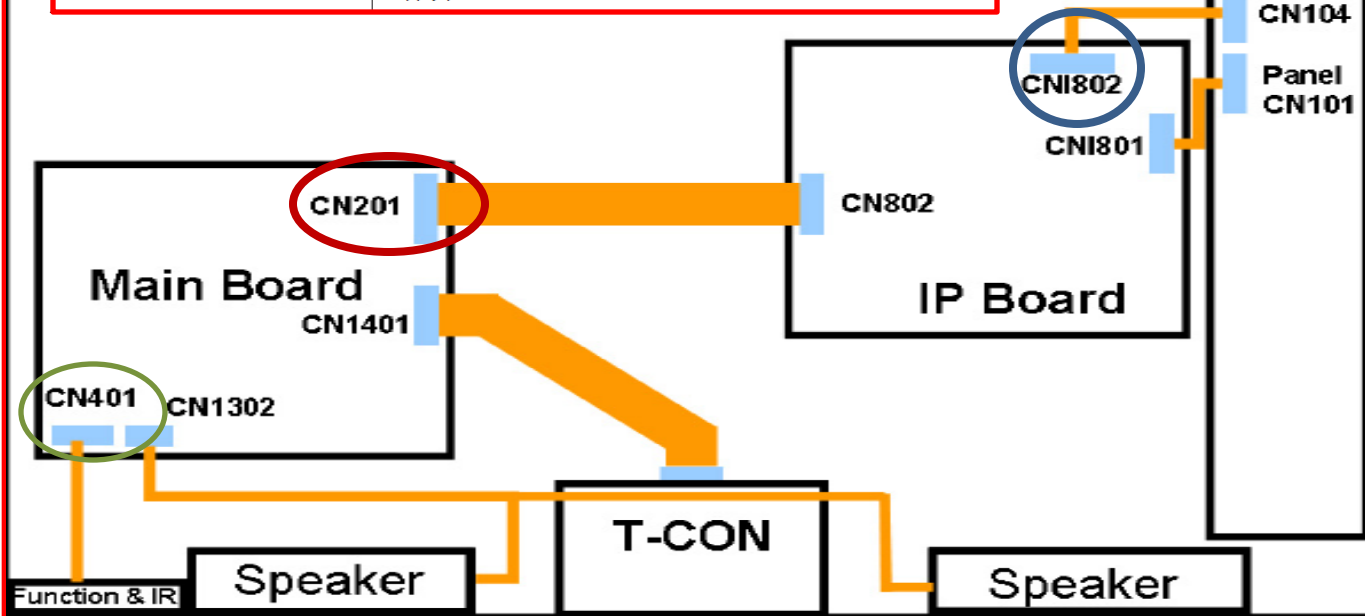
Connector	Function
CN201 → CN802	Supply main power and dimming signal from IP board to Main Board.
CN1401 → CN505	The LVDS signal transferred from Main Board to Panel .
CNI802 → Panel CN104	Feedback signal from driver.
CNI801 → Panel CN101	Supply power from IP board to Driver Board.
